FLEXURAL CAPACITY OF CORRODED POST-TENSIONED CONCRETE BEAMS: LARGE SCALE TESTS AND NUMERICAL SIMULATION

Flexural capacity of corroded post-tensioned concrete beams: large scale tests and numerical simulation

Antonino Recupero^a, Nino Spinella^b, Antonio R. Mari^c, Jesús M. Bairán^d

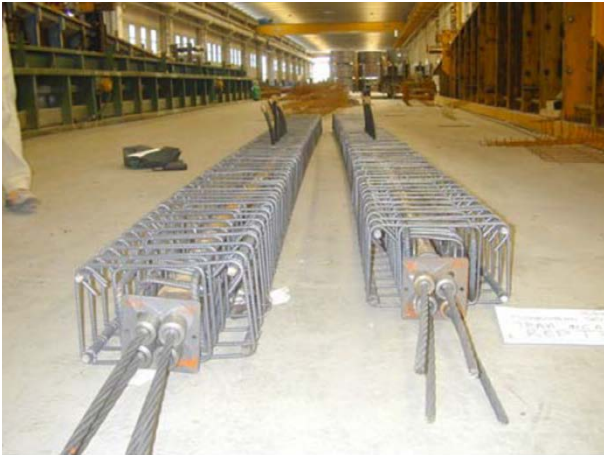
The PC specimens had a rectangular shape (400×250 mm) and a total length of 6300 mm. Prestressing was carried out using 4 tendons of 7-wire 0.6” strands, and steel with an ultimate tension capacity of $f_{ys} = 1860$ MPa was used. The cable was placed along the

centroid axis (Fig. 1). The longitudinal reinforcement was achieved with $2\phi 18$ both at top and bottom of the cross-section. The transverse reinforcement was realized with closed stirrups $\phi 8/100$ mm, except for a closest spacing (80 mm) at the ends of the beam and for a transfer length of 800 mm (Fig. 1). The FeB44k steel rebar was used, with a minimum yield strength of 430 MPa.

Figure 1. Reinforcement setup.

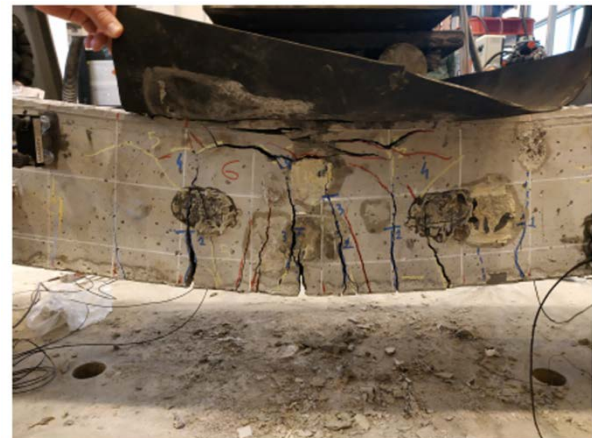
The response behavior has been also linear until a maximum load of less than 60 kN, see Figure 5.

Figure 5. Crack pattern at failure of beam T3a.

It is almost half of the bearing load achieved by the T1 beam. At the fourth cycle the maximum load bearing capacity of the beam (about 60 kN) has been recorded. The force peak has been followed by a load abruptly decay, and a typical noise of steel breaking has been heard. Probably a strand broke or frayed,

in fact the next cycles have been characterized by both lower stiffness and load, with subsequent drops of force. The corrosion in the middle of the tendon has drastically changed the capacity of the beam.

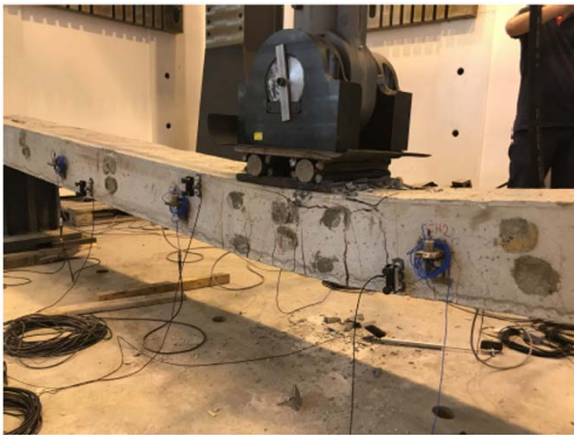
The response behavior has been almost linear until a load less than 50 kN. At the fourth cycle, the stiffness decay, and the load-displacement curve showed a new branch with different slope. The last cycle has allowed to achieve the maximum load bearing capacity of the beam (more than 60 kN), followed by two subsequent drops of force.

Figura 6. Crack pattern at failure of beam T4a.

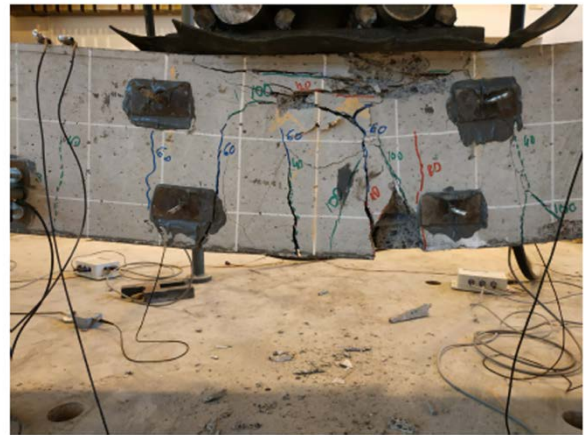
At the fourth cycle, the stiffness has decayed, and the load-displacement curve showed a new ascending branch with a different slope. Then, at the sixth cycle (100 mm), the maximum load bearing capacity of the beam (about 120 kN) has been reached.

Figura 7. Crack pattern at failure of beam T6a.

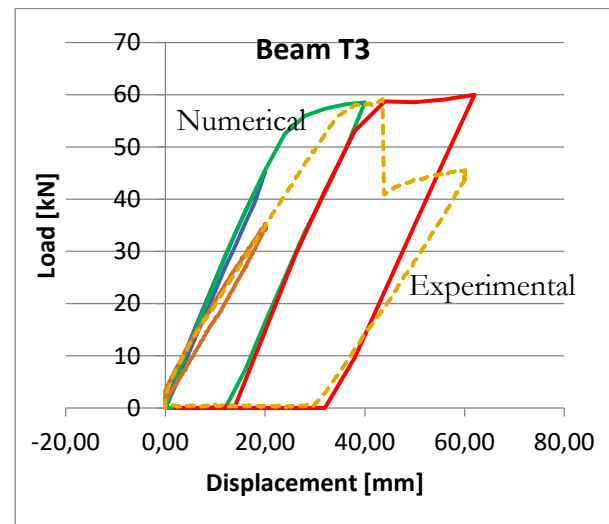
Beam T3 was corroded in a portion of 1 m length placed at mid-span of the beam. The test was performed under imposed displacements, unloading until zero load was reached, for each cycle. Figure 11 shows the theoretical and the experimentally measured load-deflection curves

Figure 11. Load-displacement curves, beam T3a

It can be observed that the ultimate capacity has been well captured by the numerical model, but there are differences in the shape of the load-displacement curves. The experimental curve shows a lower stiffness and, in addition, a sudden drop of capacity for an imposed displacement of 50 mm, probably due to the break of a wire. Such phenomenon has been not captured by the model, since the constitutive equation of the steel has not been modified as consequence of the corrosion.
